Brief overview of the Beit Lahiya wastewater emergency, 27th March 2009, North Gaza Governorate, Gaza Strip

Background

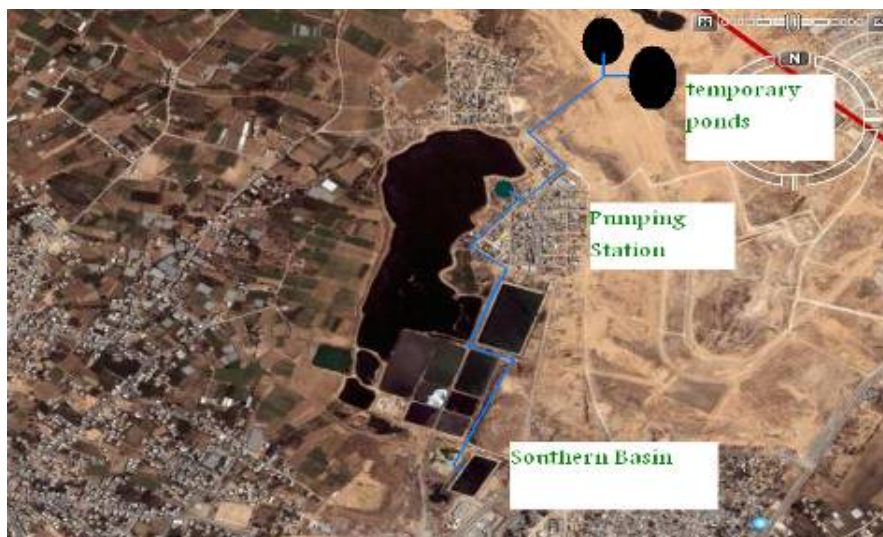
The Beit Lahiya Wastewater Treatment Plant (BLWTP) in North Gaza Governorate is shown in aerial view in Figure 1.

Figure 1 Aerial view of Beit Lahiya Wastewater Treatment Plant (CMWU and InfraMan 2007:8)

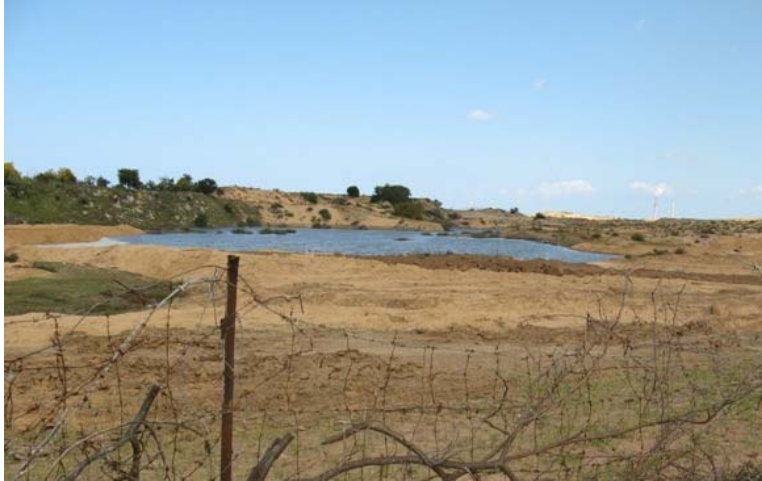
Early Morning 27th March 2009, wastewater pumped from the large infiltration lagoon (containing about 2 million cubic metres [m³] of wastewater) to the two temporary disposal ponds (estimated maximum volume of 250,000 m³)¹ about 1.2km to the north (near the red line) overflowed the banks, caused erosion and damage, and about 40-50,000 m³ of treated wastewater escaped down a natural Wadi towards the Bedouin Um AlNasser Village. This happened Friday morning, no one was hurt or any houses flooded or damaged. A CMWU team visited the site with coordination from Israel on Friday 27th March, and commenced an emergency response. Pumping from the large infiltration lagoon was stopped, and contractors were engaged to deposit sand to prevent any further flow of wastewater towards Um AlNasser Village.

Figure 2 The stationary front edge of the estimated 40-50,000 m³ wastewater that escaped from the temporary disposal ponds overnight/early morning of Thursday 26th/Friday 27th March 2009 (Photograph by the WASH Cluster Team, Sunday 29th March)

Figures 2-5 taken on the morning of Sunday 30th March show the spilled wastewater, Um AlNasser Village, and activities of the CMWU contractor to arrest any further spread of the wastewater. The General Director of the CMWU, Monther Shoblak, is currently coordinating with the Israel authorities to proceed with repairs to the damaged walls of temporary disposal ponds.

CMWU will coordinate with Israel to undertake emergency repairs to the damaged temporary disposal ponds as soon as possible, and will provide an update report to the WASH Cluster Coordination meeting on Tuesday 31st March 2009 at 2.00pm in the UNDP Building in Gaza City. The CMWU engineers believe there is no risk of any further spillage of wastewater from the temporary disposal ponds, and the spilled wastewater is rapidly infiltrating the Wadi sand.

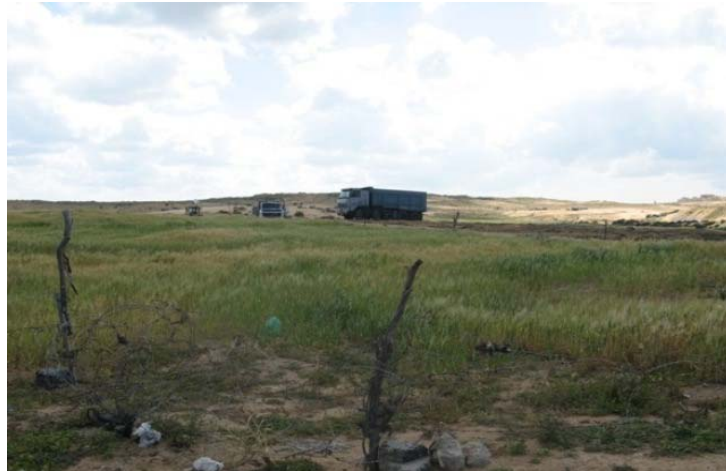
Figure 3 Sand being collected by the CMWU contactor close to the leading edge of the escaped wastewater (Photograph by the WASH Cluster Team, Sunday 29th March)

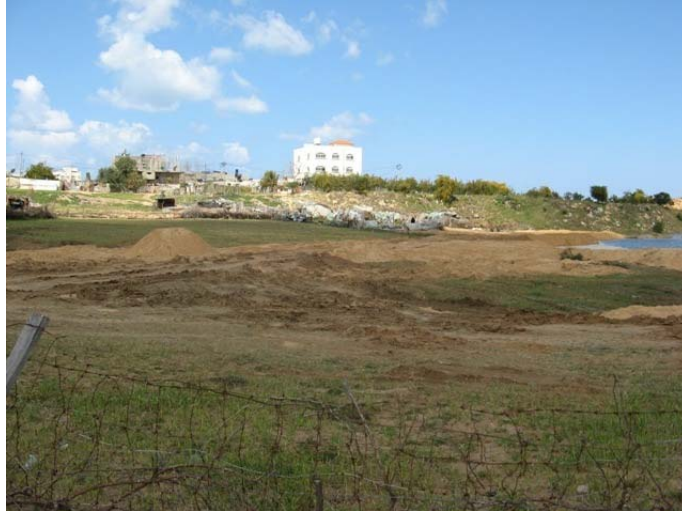
Figure 4 Emelnasser Village close to the stationery leading edge of the escaped wastewater, and the sand deposited by the CMWU contractor (Photograph by the WASH Cluster Team, Sunday 29th March)

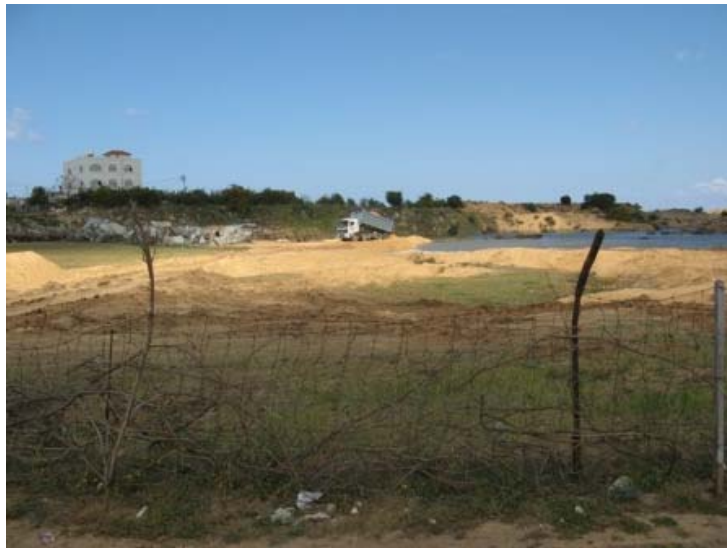
Figure 5 Sand being dropped by the CMWU contractor at the stationery leading edge of the escaped wastewater (Photograph by the WASH Cluster Team, Sunday 29th March)
